## Geomorphic Fans and Their Watersheds: managing risky systems

David J. Wilford, PhD, PGeo, RPF  
B.C. Ministry of Forests and Range  
Bag 6000  
Smithers, B.C., Canada, V0J 2N0  
[dave.wilford@gov.bc.ca](mailto:dave.wilford@gov.bc.ca)

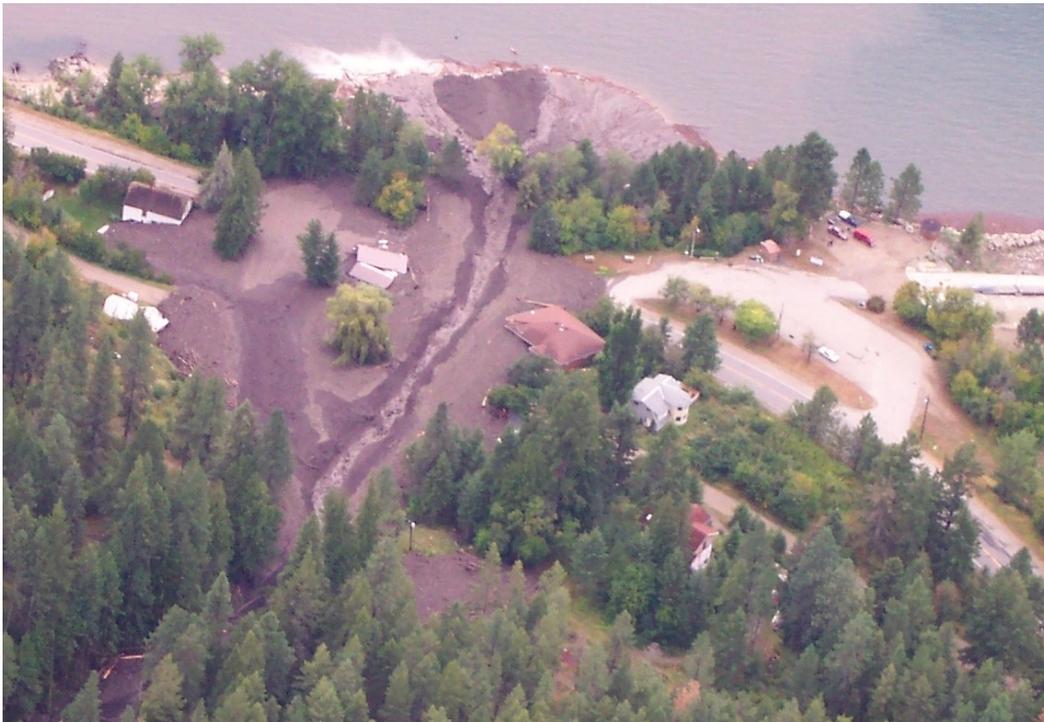
Figure 1. A debris flow initiated as a result of a localized heavy summer rain shower in a watershed following wildfire. Two homes were destroyed and the highway was closed for several days. (Source: D. Boyer, B.C. Ministry of Environment.)

History has demonstrated that hydrogeomorphic hazards exist for infrastructure on geomorphic fans, including loss of lives, damaged roads and drainage structures, destroyed homes, and overwhelmed water intakes (Figure 1). While site investigations are essential for developments on fans, it is critical to assess the associated watershed for hydrogeomorphic hazards. Natural processes such as wildfires and land use changes such as timber harvesting can influence the hydrogeomorphic processes in a watershed with potentially significant implications for downstream fans. A 5-step approach is presented to analyze risks from the perspective of the fan-watershed system.
